Lísted Buíldíngs

Homíngton

Homington Farmhouse

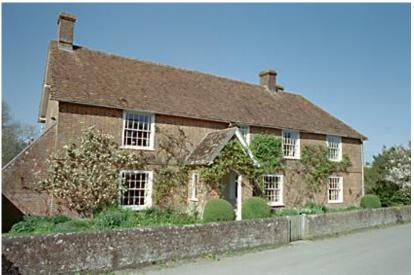
HOMINGTON VILLAGE (north side) Homington Farmhouse and attached farm buildings II Farmhouse with attached C19 farm buildings to rear. Mid-C18 with alterations of C19. Flemish bond brick, tiled roof, hipped to right, brick stacks. L-plan. 2-storey, 3-window front. Partly glazed door with fielded panels, in gabled brick porch to left of centre, to left and to right is 16-pane sash with margin lights, to right is blind segmental-arched window. 3-brick plat band to first floor, two 16-pane sashes with margin-lights, one 12-pane sash and one square blind window to right.

Right return is C19 rebuild, 16- pane sash and 3-light casement to ground floor, with 16-pane sash and leaded 3-light casement to first floor. Left return has lean- to against ground floor, vitrified brick lozenge decoration to first floor attic, has casement. Rear has C19 lean-to up to ground floor, one 2-light casement to first floor, to left is 2-storey wing rebuilt in mid-C19, with casements. Interior has chamfered beams with runout stops and planked doors to first floor. Attached to rear are C19 single-storey farm buildings, enclosing a courtyard on three sides. Flemish garden wall bond brick and tiled roofs, planked stable doors and casements.).
