THE EXCAVATION OF THE DEFENCES OF DEVIZES, WILTS., 1974

by JEREMY HASLAM

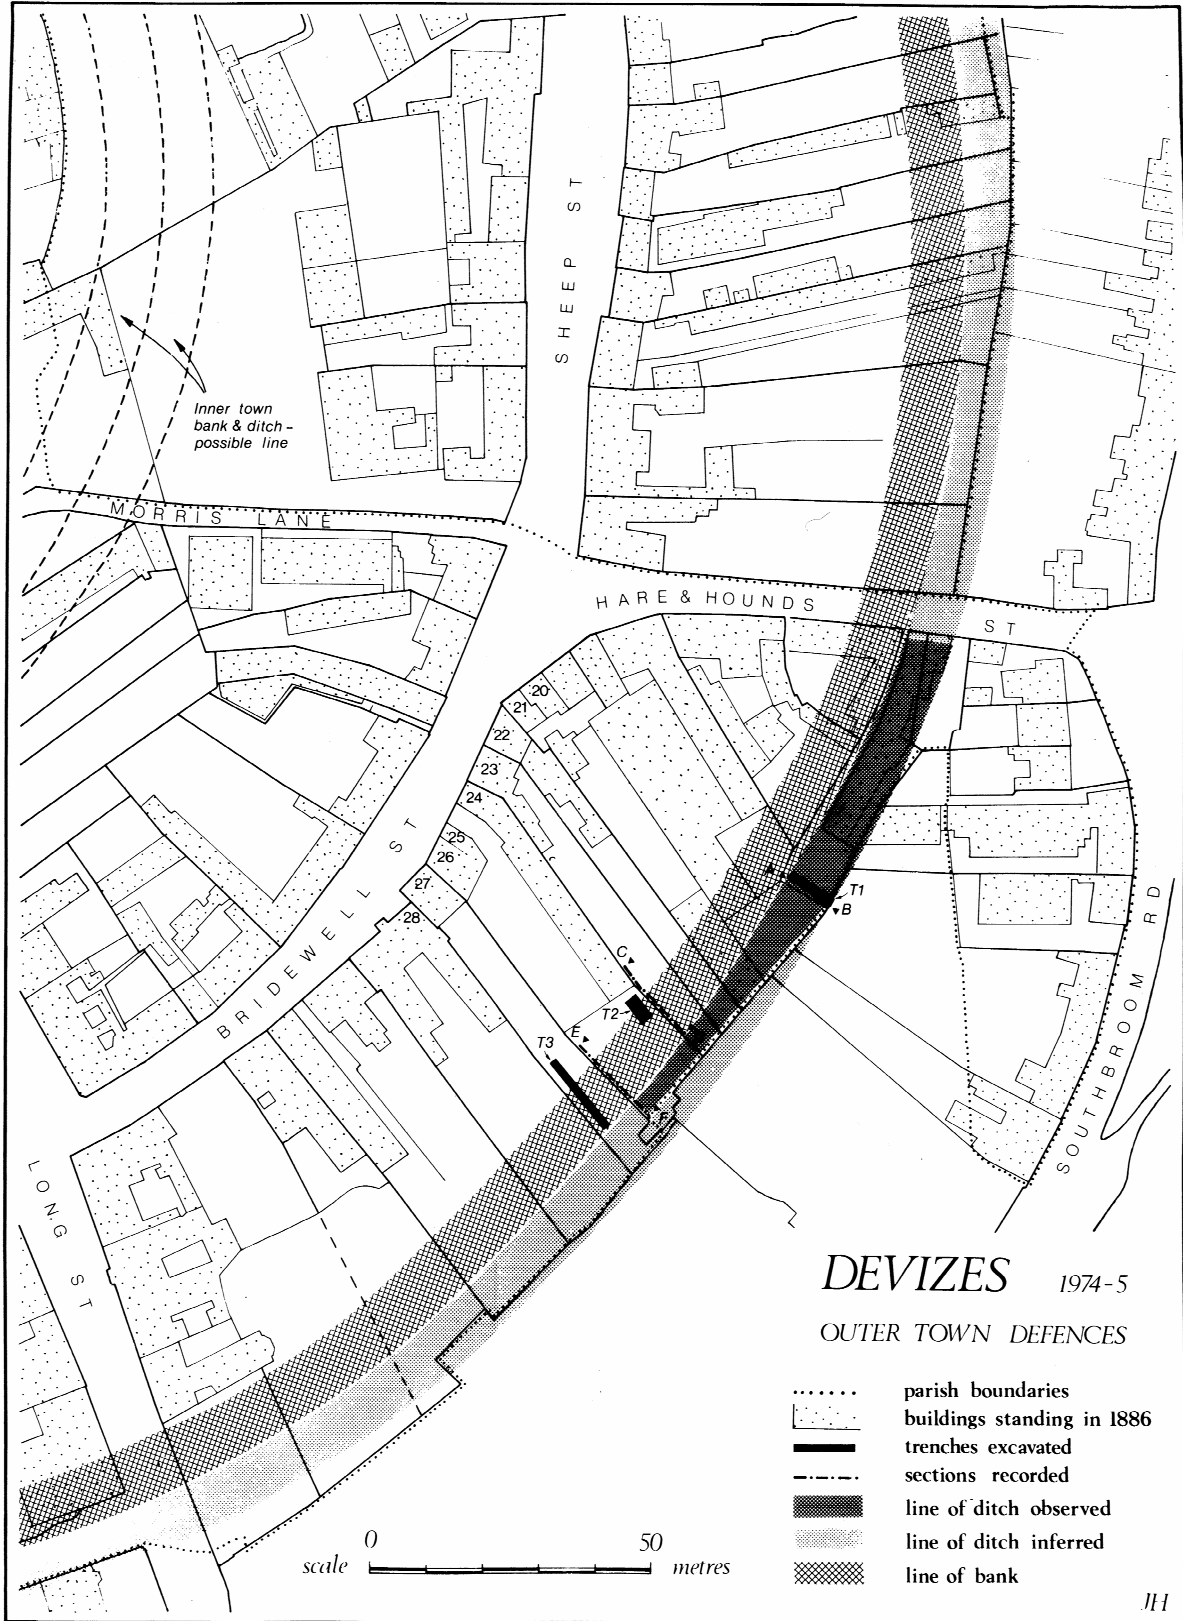
FIG. 1. Plan of trenches, & defences on the E side of Devizes. Based on the 1:500 Ordnance Survey plan, 1885-6.

IN SEPTEMBER 1974 an excavation was undertaken by the writer on sites on the line of the outer defences of Devizes S of Hare and Hounds Street on the E side of the town (FIG. 1). This was in advance of renovation and building works by the Kennet District Council in the area bounded by Hare and Hounds Street to the N, Southbroom Road to the E, and Bridewell Street to the W. It was the first of a series of excavations on urban sites undertaken by the writer on behalf of the Wiltshire Archaeological Society and the Department of the Environment.¹ The excavation was designed to investigate the line of the outer defensive ditch of the Norman town, to obtain dating evidence for its construction, and to explore the relationship of this ditch to the presumed bank running along its inner edge. Further archaeological observations were also made during contractors' excavations in April 1976, when sections across the line of the bank and ditch (C-D and E-F) were exposed.

Three trenches were excavated, the first (T1, FIG. 1) across the presumed line of the ditch, and two others (T2 and T3) across the presumed line of the inner bank in the back gardens of nos. 24 and 27 Bridewell Street. The section across the ditch was excavated mainly by machine, but the lowest metre of the filling was dug by hand; the other sections, owing to difficulties of access, were excavated entirely by hand.

contractors' excavations revealed the inner lip of the ditch 50 m to the SW of the first excavation (section E-F, FIG. 1). From these observations it was clear that the property boundary forming (until recently) the rear of the gardens of nos. 20-26 Bridewell Street lay along the approximate centre of the ditch, rather than along its outer edge (see plan, FIG. 1). Furthermore, when the conjectured course of the ditch to the SW is plotted on a large scale plan (FIG. 1)⁴ it appears that the parish boundary which follows the rear of the property boundaries takes an erratic course between the middle of the ditch and its outer edge. The ditches, rather than the banks, in other parts of the town (except along the E line of the castle bailey) have therefore been shown in FIG. 3 as following the line of the parish boundaries.

The sequence of stratification observed most clearly in trench 2 was duplicated in the contractors' excavation of April 1976, which exposed two sections, one across the line of the presumed bank to the N and E of Albert Terrace (section C-D, FIG. 1), and a second across the upper part of the inner half of the ditch, and the outer edge of the bank (section E-F). For a considerable length of section C-D a layer of slightly earthy, probably redeposited, Greensand, 30-50 cm in thickness, was observed to overlie a layer of brown loamy sand. This latter merged into natural Greensand below and was probably therefore a buried soil. The horizontal extent of the sandy layer and the fact that in every place it sealed what appeared to be a buried soil, strengthens the suggestion that it represents the denuded remains of an original bank which was probably slighted and in part, at least, thrown back into the ditch. In section E-F the fill of the upper part of the ditch consisted of homogeneous sandy earth which was rather darker than the filling of the ditch in trench 1. The inner lip of the ditch was accurately plotted at this point, and immediately to the NW the same sequence of discoloured Greensand overlying a brown soil horizon suggested the remains of the former bank, reinforcing the conclusions gained from section C-D. Clearance work by the contractors also revealed in plan a considerable length of the ditch between Hare and Hounds Street to the N, and the line of section E-F to the S (FIG. 1).

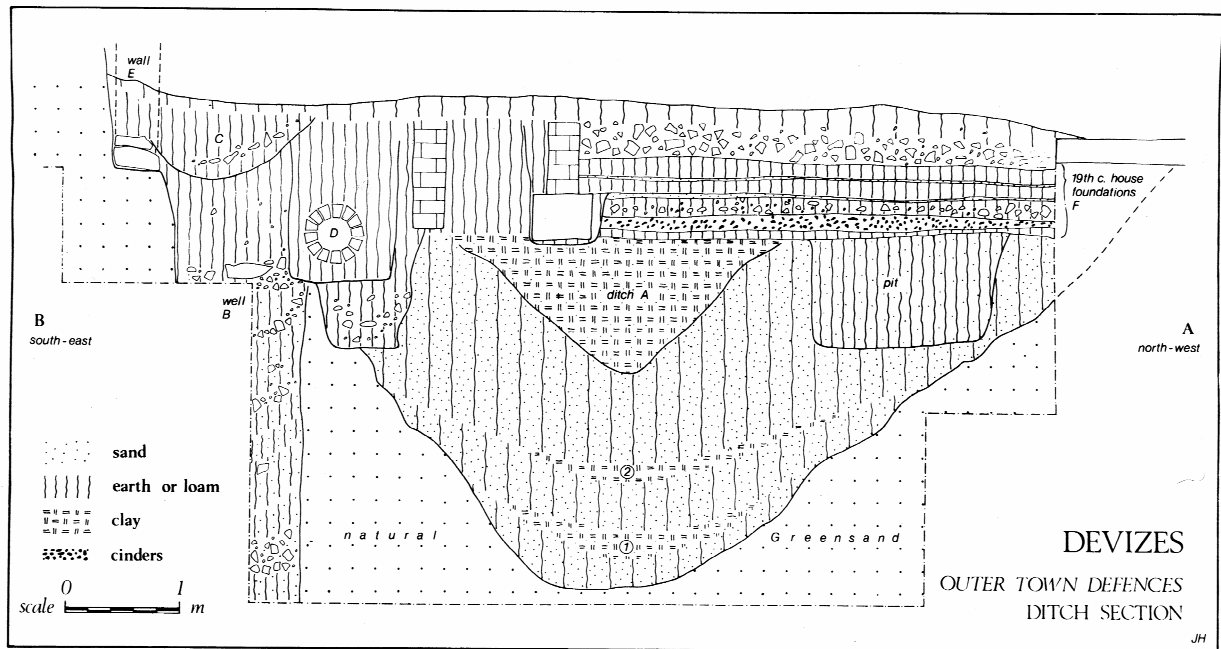
Trench 1 (Section A-B, FIG. 2).

The ditch was cut into Greensand to a depth of about 5 m from the highest surviving level of the natural rock on the outer (SE) edge. The inner lip of the ditch had been disturbed where its upper edge should have been, and the ground immediately to the NE had been completely removed by recent development. In profile (FIG. 2) the ditch was an irregular wide V-shape, with a rounded rather than angular base. Its outer edge was cut in both of the exposed sections in the ditch by a well (feature B on section, FIG. 2) of probably 18th century date. The latter had in turn been cut by a 19th- early 20th century pit (feature C), as well as by a trench running along the length of the ditch (NE – SW) and containing a brick lined sewer or drain (feature D), probably also of 19th century date. The well appeared to respect a brick wall with a stone base (feature E) cut into the Greensand, which followed

FIG. 2. Section of defensive ditch, trench 1.

The filling of the ditch consisted of homogeneous, slightly clayey Greensand with only lenses of different materials: a thin layer (1, FIG. 2) of purple sandy clay about 50 cm above the bottom, and another thin layer (2) of grey-brown clay 70 cm above this. A shallower ditch (feature A) of similar profile to the earlier one had been cut into its filling along its centre line. This secondary ditch was filled with a layer of slightly sandy stiff greenish-brown clay. Into the top of its filling had been set the brick foundations of a house of probably 19th century date (feature F).

No pottery was recovered from the filling of the ditch. A number of small post-medieval sherds were found on the spoil heaps but none was from a stratified context. In view of this lack of dating material it is difficult to make any deductions about the date at which the ditch was last exposed. Since, however, there were no deposits in its lower filling which suggested that layers had accumulated naturally over any length of time, it is clear that the ditch must have been kept cleaned out during the period immediately following its construction. It is also clear from the generally homogenous nature of its filling that at least the upper three quarters of the ditch must have been backfilled in one operation, presumably from the material comprising the bank.

The ditch was also found at one point to have been recut to a depth of 2.5 m below the highest level of natural Greensand on its outer edge. The upper levels of this recut had, however, been truncated by the construction levels of a 19th century house, making it difficult to reconstruct the surface from which this was originally excavated. It is not possible to say on present evidence whether this recutting was primarily for defensive purposes or for drainage.

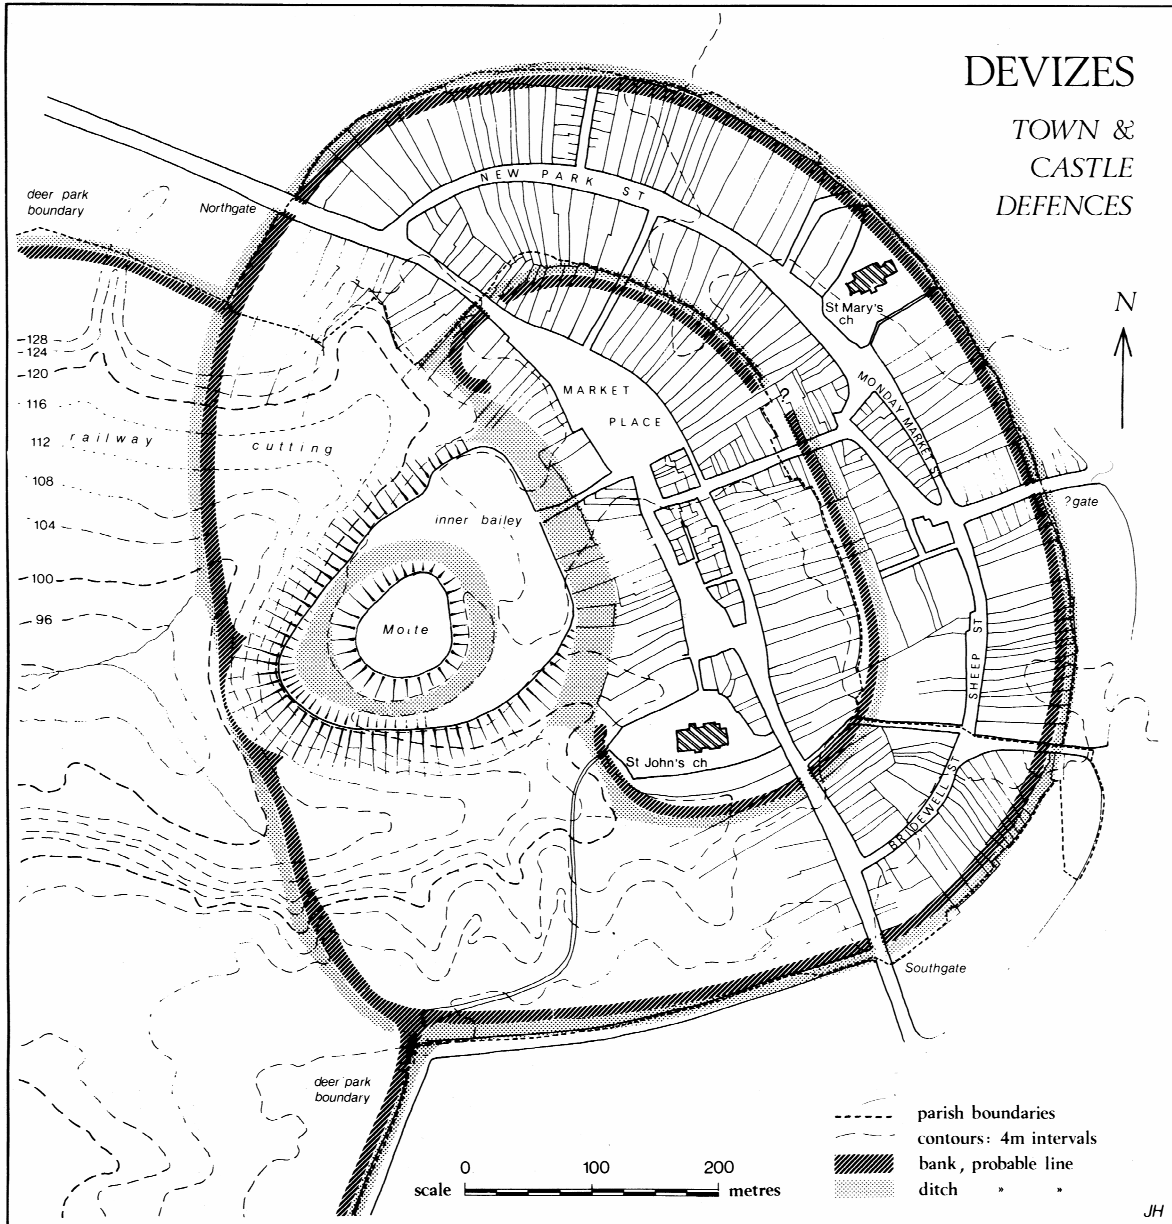
FIG. 3. Plan of Devizes with reconstructed 12th century castle and town defences. Based on the second edition 1:2500 Ordnance Survey plan, 1900.
