Listed Buildings/ Monuments

Dinton

Dinton Lodge

Grade II - Listed 6th April, 2004

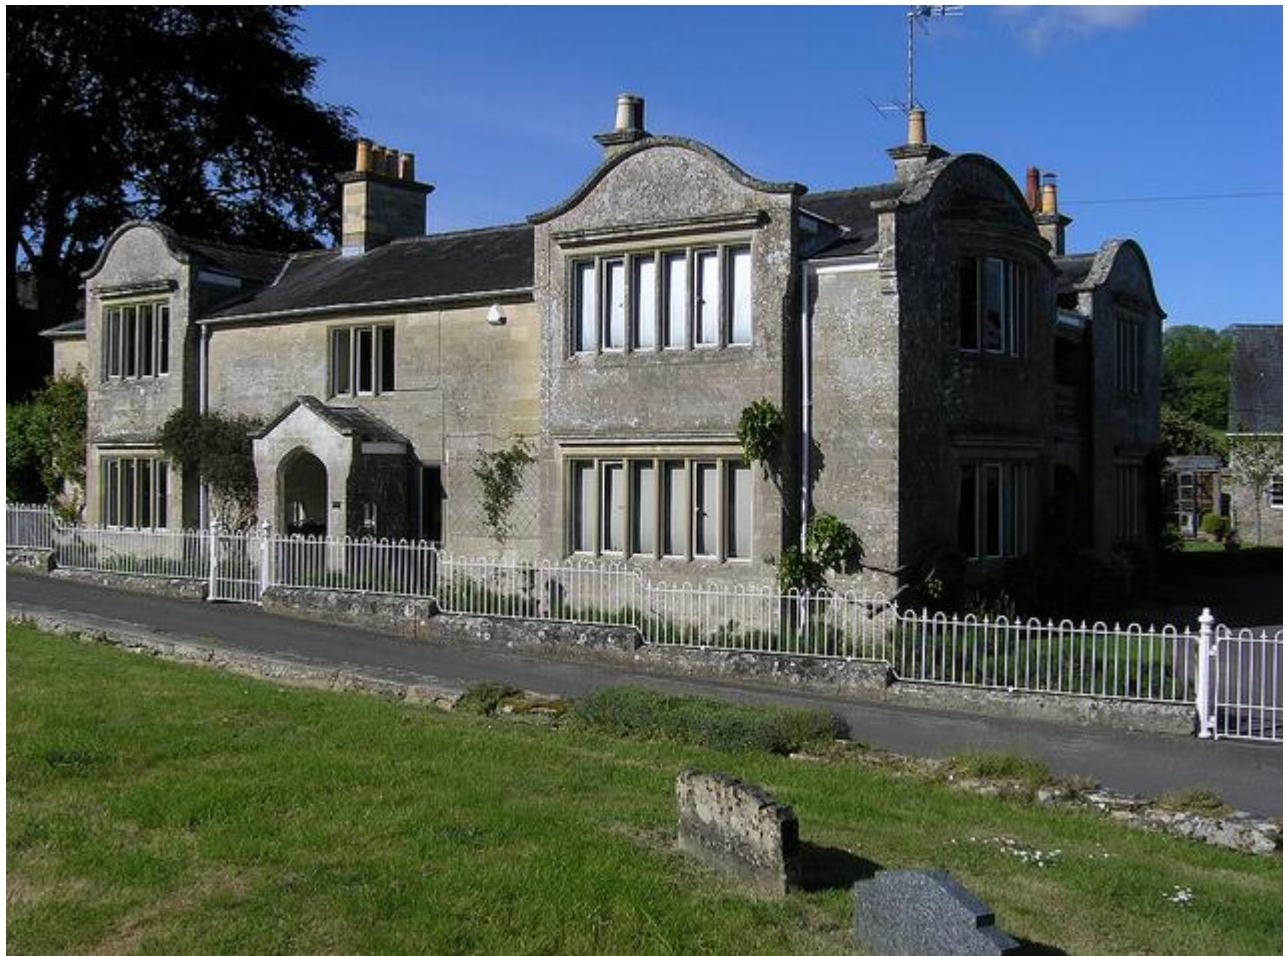
Dinton Lodge – Photo by Phil Draper

A late C19 house, which appears to incorporate a mid C18 house, constructed of Chilmark stone ashlar. The house has a Welsh slate roof, hipped and gabled ends and ashlar axial stacks with moulded cornices and yellow clay pots.

EXTERIOR: The two storey house has an asymmetrical 3-window south west front with 1-3-4- and 6-light moulded stone mullion windows with drip moulds. To the left and right are projecting bays with curved gables with moulded copings, the right-hand bay being slightly wider. It has a central doorway with a gabled stone porch with a 4-centred arch doorway with flanking single-light windows. The south-east facade has 3-bays with a curved gable bay to left with wide 2-storey stone bow windows. The bay to the right has two four light stone mullion windows. The central recessed bay has an arched porch with a balcony with a stone balustrade above. An engraved date stone of 1896 is set in the porch with stones on either side engraved with the initials J.P.M. and O.S.M.P.M. The garden to the south-east is enclosed by decorative cast iron railings set on an ashlar plinth with terminal piers, stanchions and alternating spear head and looped shafts with top and bottom rails.
